**NISTIR 5389**

# **Analysis of Failed Dry Pipe Fire Suppression System Couplings From The Filene Center at Wolf Trap Farm Park for the Performing Arts**

March 1994

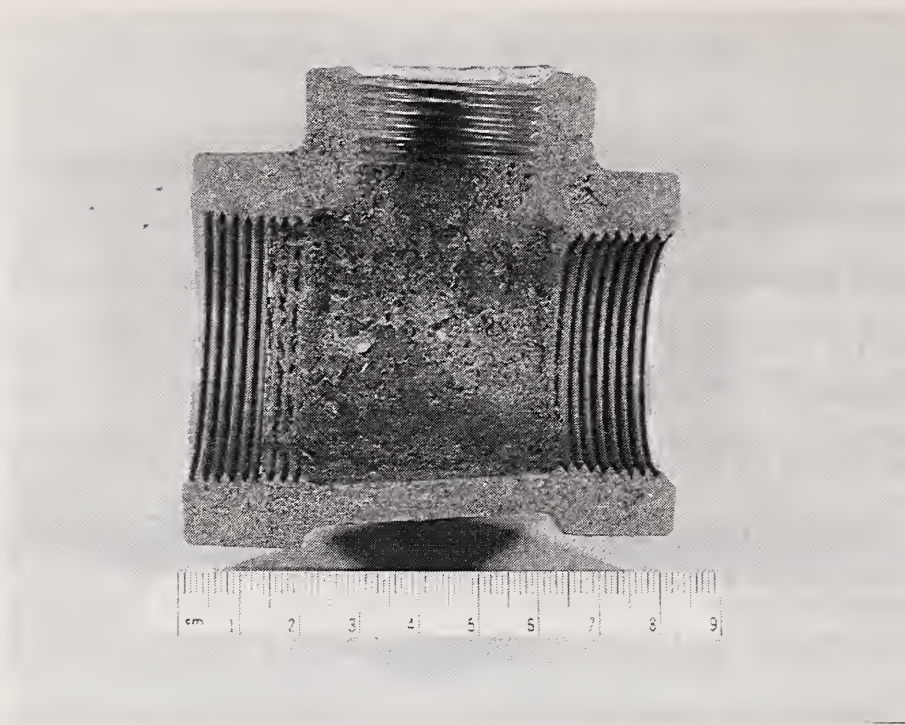
symmetrical about the long axis of the component.<sup>(9)</sup> In the case of the "T" couplings, casting seams were present along the long axis. In general, the seam is the weakest part of a casting and as a result, the principal cracks are believed to have nucleated in this region and propagated along the length, effectively splitting the couplings in two. This type of failure is shown in Figure 1.

**Figure 1** Optical micrograph showing a brittle fracture along the casting seam of a failed cast iron coupling taken from the Filene Center.

The results of this analysis also indicate that the potential for catastrophic failure of the couplings within this fire suppression system may be reduced by a total replacement of the gray cast iron couplings with a material which is more resistant to brittle fracture. Some carbon steel alloys may be suitable for this purpose. The best recommendation to alleviate this problem is to remove all of the water from the system. More drains located in the key low points throughout the system could reduce the amount of residual water substantially .

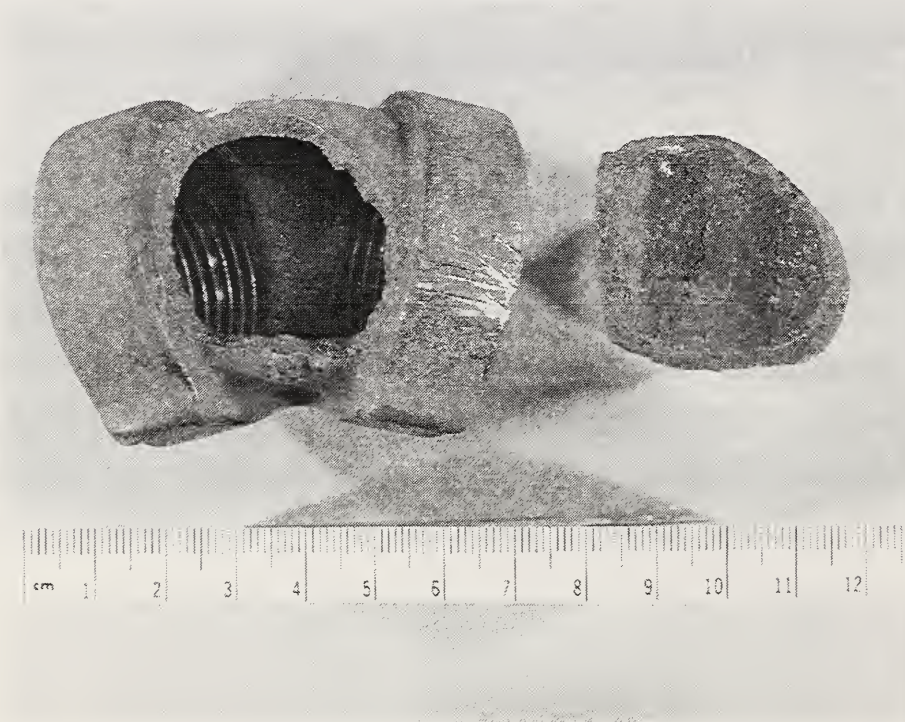
The failures observed in the elbow sections were also determined to be the result of the stresses induced by the expansion of water. In these specimens, failures were observed in the "knee" region of the casting as shown in Figure 2. The radius, or knee, is typically the weakest region in an elbow fitting.

**Figure 2** Optical micrograph showing a brittle fracture located in the radius of a failed cast iron elbow taken from the Filene Center.

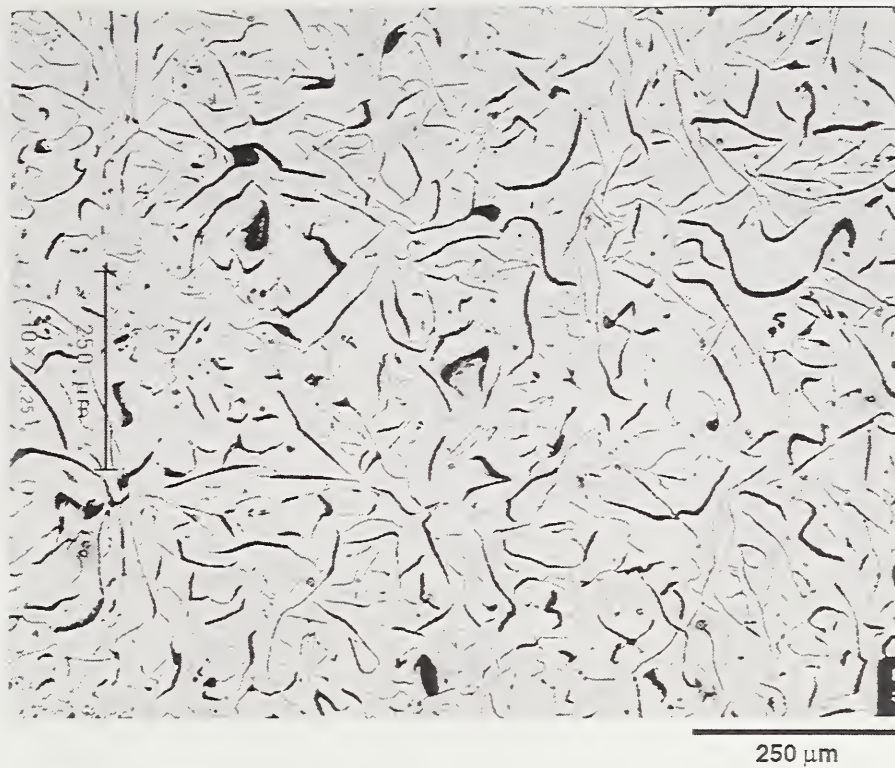
Sections were cut from the couplings and prepared for metallographic analysis using standard procedures.<sup>(5)</sup> The polished surfaces were analyzed in both the "as polished" and the etched conditions. A 2% solution of concentrated nitric acid in methanol (nital) was the etchant used for this analysis. Figures 3 and 4 are representative micrographs of a coupling section in the as polished and etched conditions, respectively. The microstructure is composed of graphite flakes in a pearlite matrix, and on this basis, the material was determined to be a Class 30 cast gray iron.<sup>(6,7)</sup>

**Figure 3** Optical micrograph in the "as polished" condition showing the microstructure of a failed cast iron coupling taken from the Filene Center.

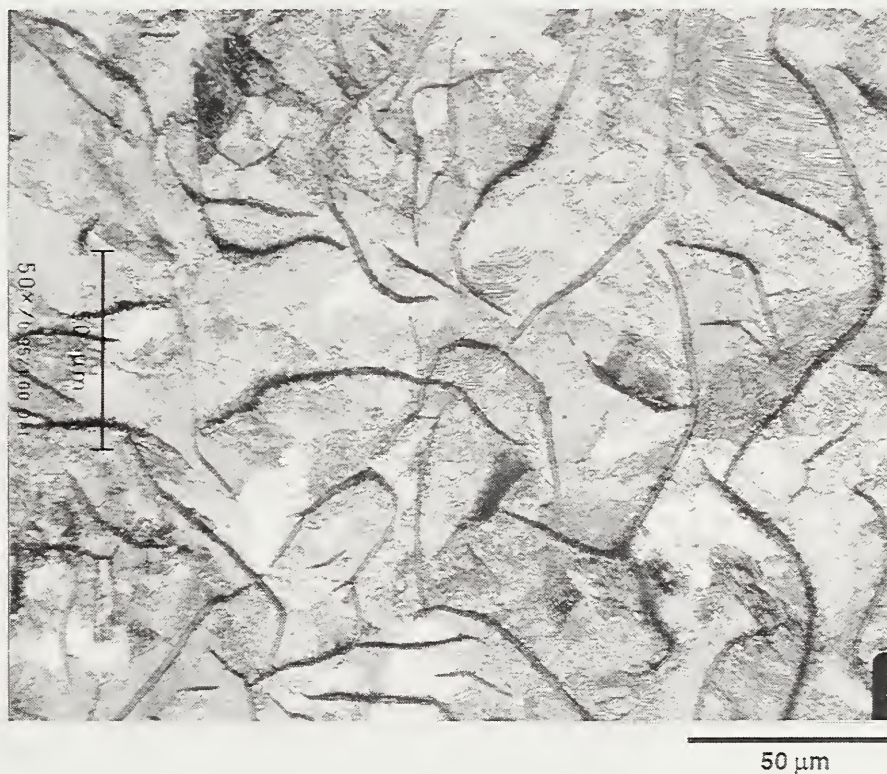
**Figure 4** Optical micrograph showing the graphite flakes in a pearlite matrix microstructure of a failed cast iron coupling taken from the Filene Center . Etchant: 2% nital

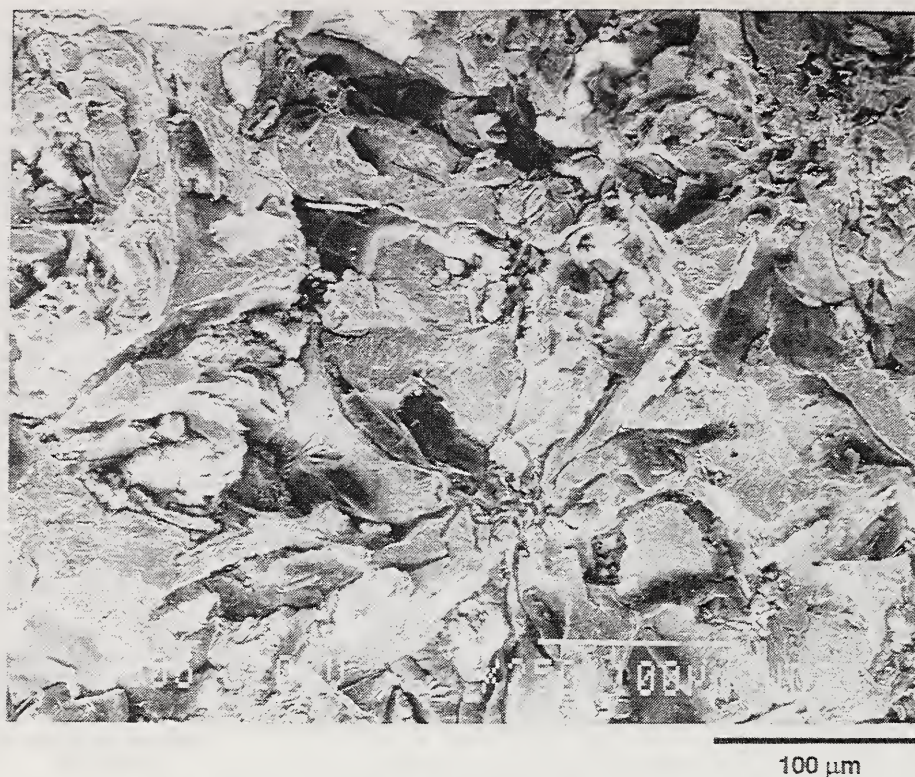
The mechanical properties of gray cast irons like the type used in the Filene Center fire suppression system are strongly dependent on the concentration and coarseness of the graphite flakes. While the graphite flakes increase the overall mechanical strength of cast iron, they tend to reduce the fracture resistance of the bulk and also act as internal notches; thereby serving as crack initiation sites.<sup>(7)</sup> Gray cast irons, in general, possess relatively low mechanical strength due to the interlaced network of graphite flakes. The interfaces between the graphite flakes and the matrix are also very weak, so once a crack has initiated in this material, little or no resistance to propagation is provided by the bulk.<sup>(7)</sup> This poor interfacial strength generally results in a brittle type of fracture along the network of graphite flakes as shown in Figure 5. Fracture of this type was observed in all of the specimens provided from the Filene Center.

**Figure 5** Low magnification scanning electron micrograph showing brittle cracking along the graphite matrix interfaces on a fracture surface taken from a failed cast iron coupling at the Filene Center.

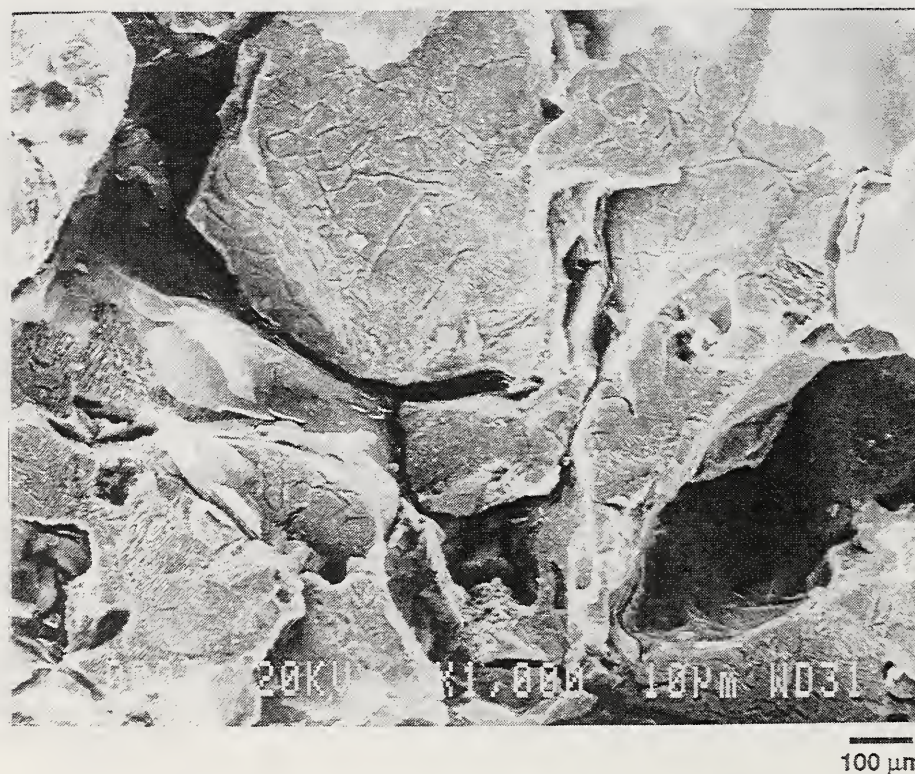
crystallographic planes.<sup>(10)</sup> This particular type of brittle fracture is known as cleavage and the characteristic features of a cleavage fracture are flat facets similar to those shown in Figure 6. The results of the fractographic analysis indicated that the fractures were completely brittle in nature and composed mostly of cleavage. No deformation indicative of a ductile type fracture was observed anywhere on the surfaces analyzed.

**Figure 6** High magnification scanning electron micrograph showing the observed cleavage facets on the fracture surfaces taken from failed cast iron couplings at the Filene Center.
